## CLP 8301 print head assembly

This document will explain the print head assembly, especially the ribbon tension, head pressure and ribbon anti-wrinkle controls shown in the picture below.

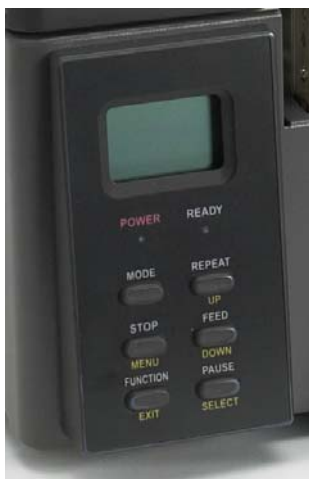
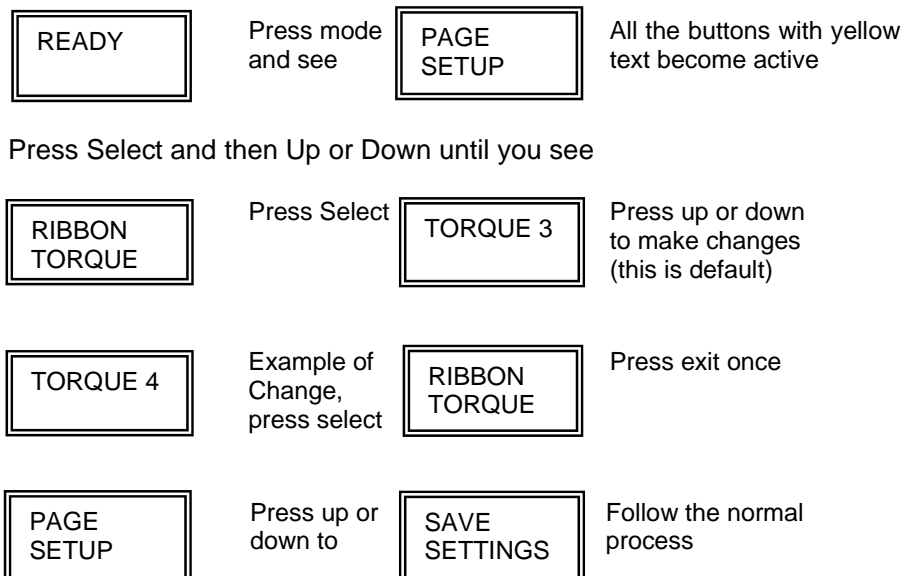
**Control panel** – using the following button pushes you can make changes to the ribbon winding torque (controlled through the control panel, by an electric motor).
