Common Problems on CLP printers or FAQ's

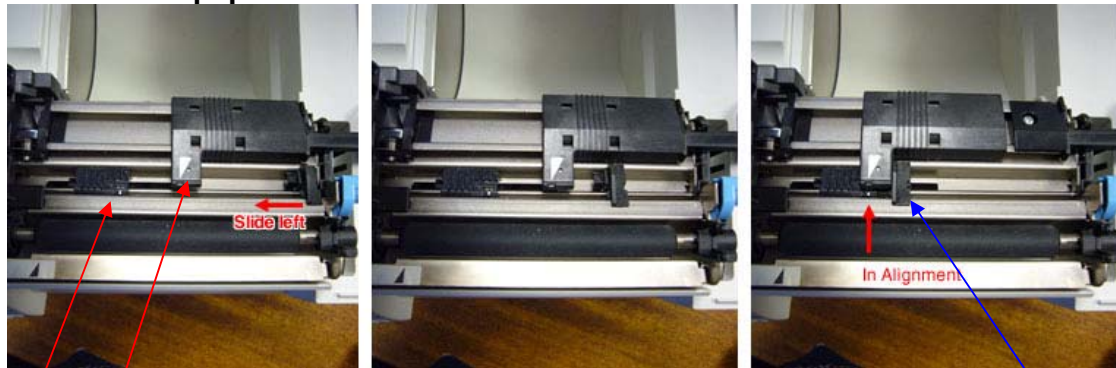
CLP 521/621 paper sensors

CLP 521/621 & CLP 8301 - Make sure the paper sensors are in line with each other, this is one of the most commonly reported problem on these printers. These two model ranges have manually adjustable, independent sensors, which occasionally get accidentally knocked out of line with each other, usually during label and ribbon reloading.

A = lower paper sensor, note the small white mark

B = Upper sensor, the final picture of the 3 shows the two sensors in line

For full width media push both the upper and lower sensors as far to the right as possible, they will stop in the middle. For media that is less than 70mm wide use the method shown above, pushing the paper guide to the left to align the sensors.

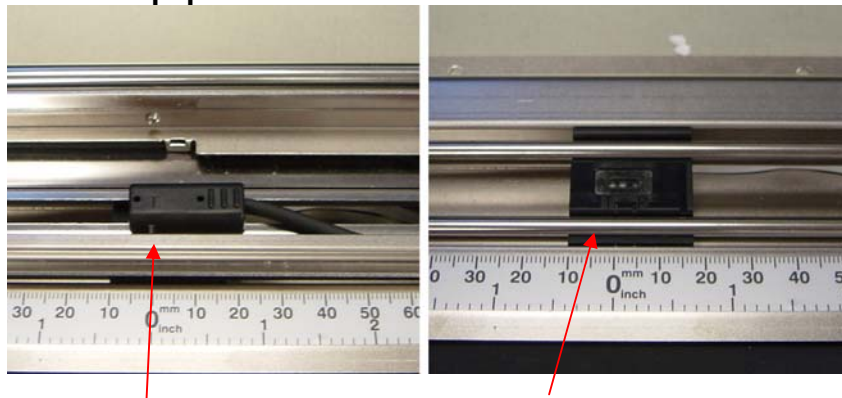
CLP 8301 paper sensors

Upper paper sensor

Lower paper sensor

Note the T marked on both halves, they need to be lined up with the same point on the measured scale, in the example that is the central zero.

CLP 8301 – Paper Jam on LCD panel – Normally just a matter of checking the paper sensors are in line. Make sure the recess marked with a T (transmissive) on the lower sensor bar is set to a point on the measuring scale. Then line the upper sensor pip to that same point. Printer should now feed paper correctly. May need to look at the Auto cal function (see paper feed issues) if the labels are still not feeding correctly. The document, "[calibrate sensor](#)" referred to, also shows pictures of the upper and lower paper sensors

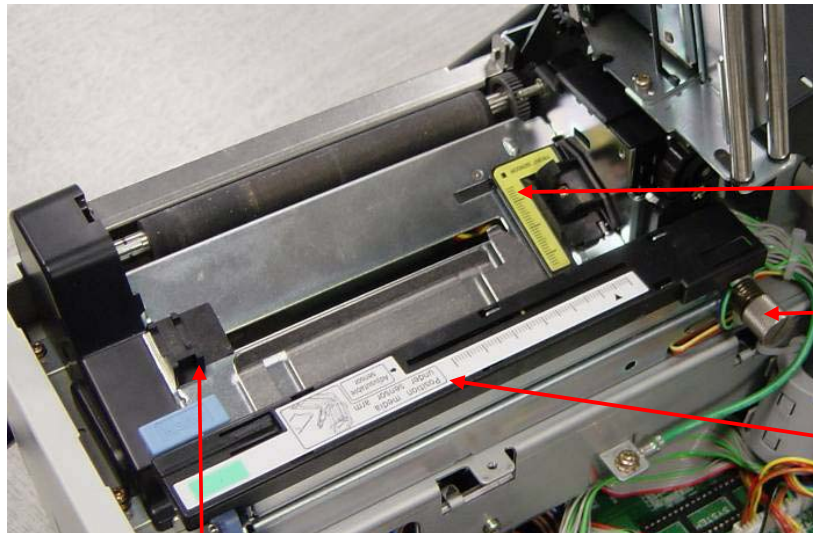
High resolution paper sensor, this lifts with the rear sensor arm

This is the knob used to adjust the paper sensor for special media etc

Rear paper sensor. Note this label states adjustable sensor even if your printer does not have it

Paper guide, this should be up against the media being printed on but not tight against it, causing drag. Similar guide used on all CLP printers
